*SPECIFICATION COMPLIANCE
CONDUCTED AT*

*PREPARED FOR
MS. NANCY ALPERT*

*NOVEMBER 2000
SRC PROJECT #1937*

*PREPARED BY
SOUTHWEST ROOFING CONSULTANTS, INC.*

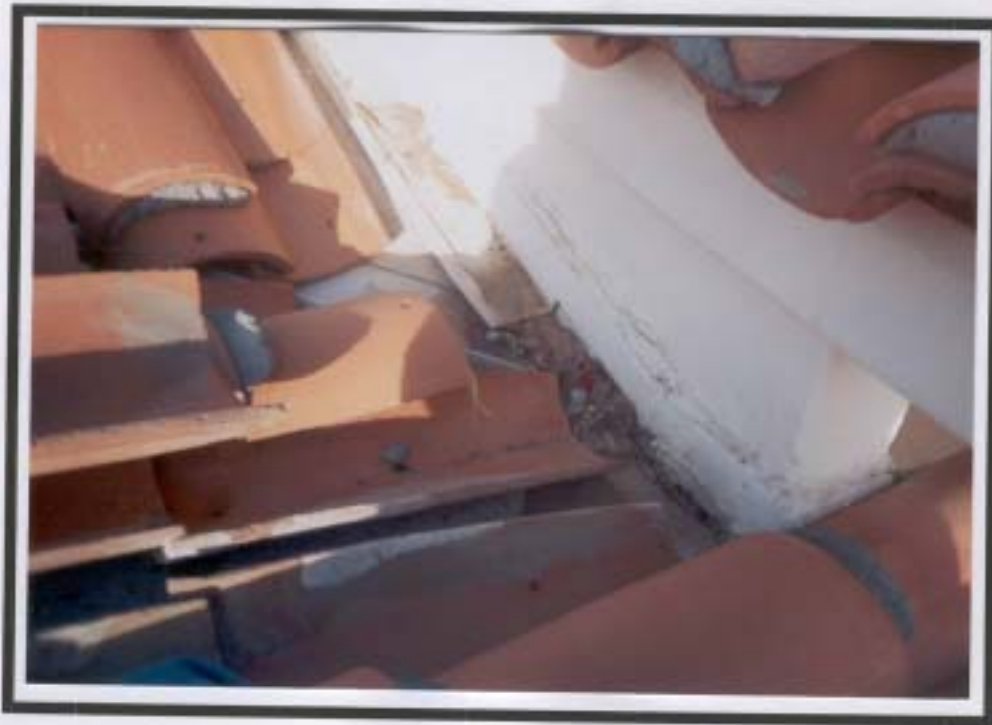
- h. Dead valleys restrict drainage potentially causing or allowing moisture entry. These areas should have been given extra attention as to installation methods and materials type.

3. Dead valley with tile tops removed. Note inadequate head lap.

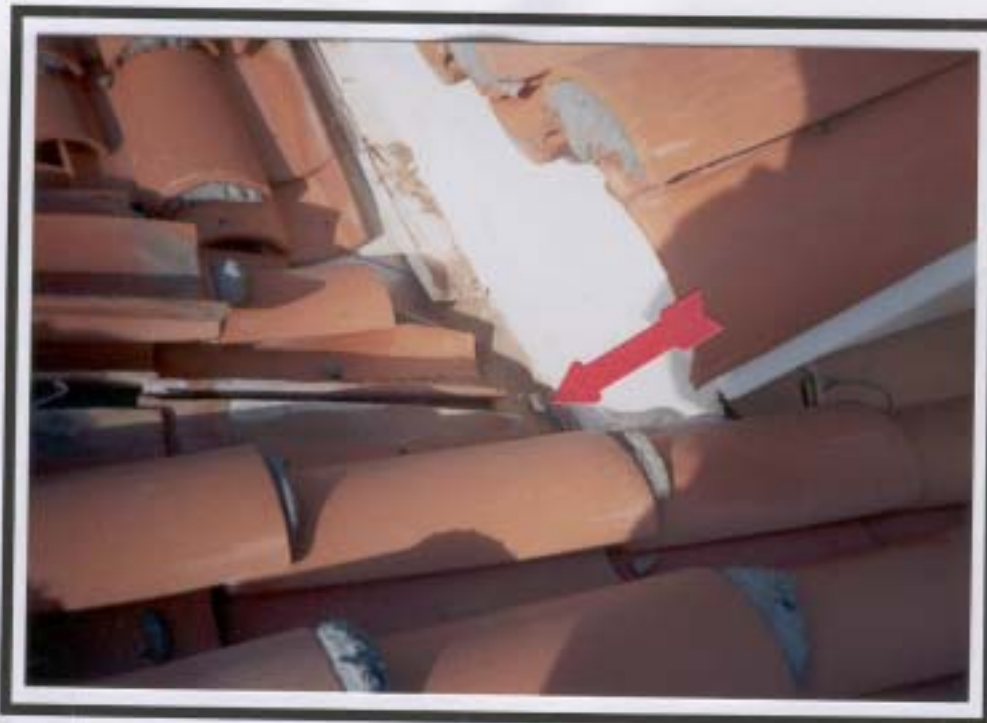
4. Dead valley with debris removed, revealing leak point.

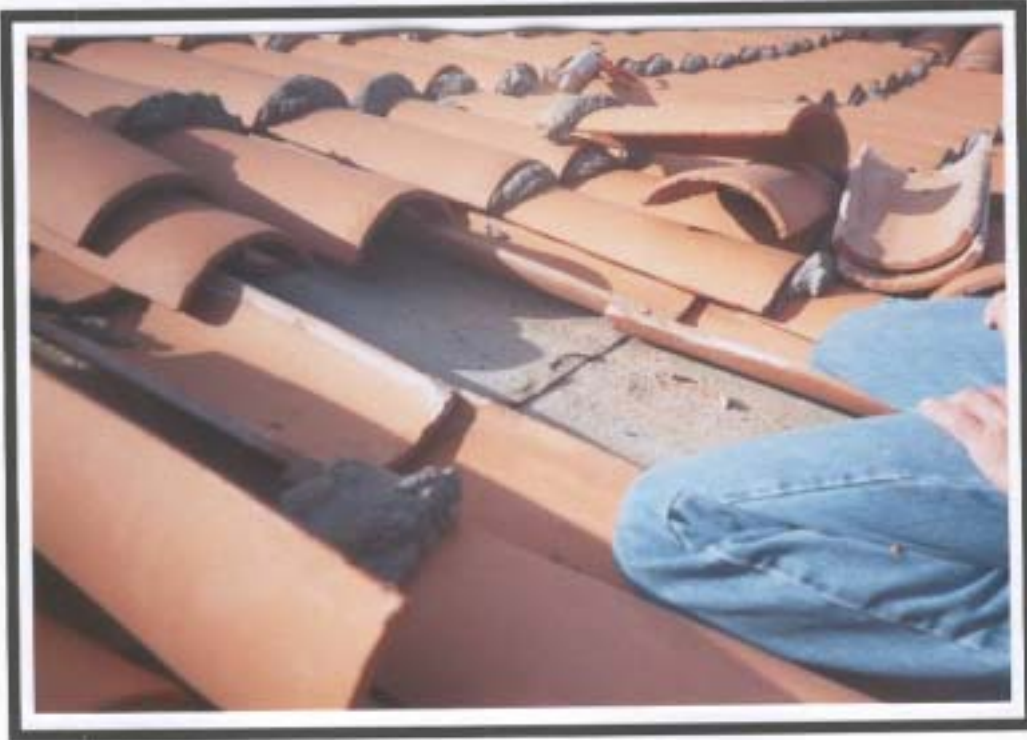
- b. Tile pans and tops are not fastened into place. Pans are loose laid with all tops mortared one to another.
 - c. 90# mineral surface capsheet underlayment is fastened in place with small staples. Lap at seams is 2" and should be 4".

7. Underlayment: Note inadequate head laps and lack of fasteners.

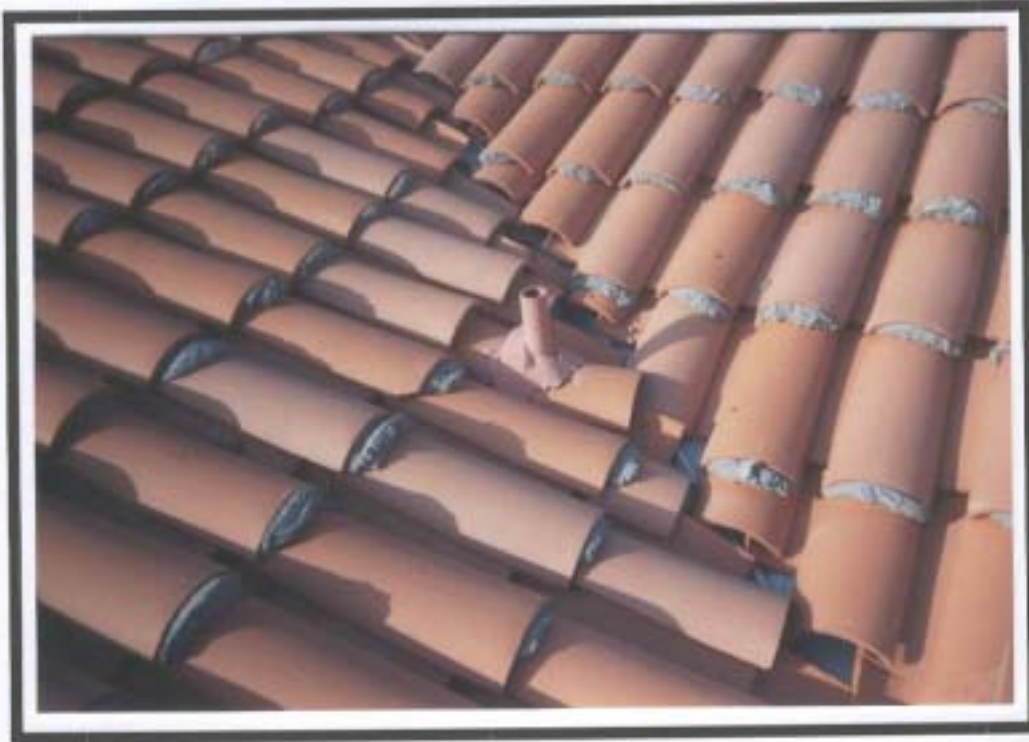
- d. Penetrations have no secondary lead flashings, and are sealed at juncture to tile with mortar.
 - e. Attic vents lack proper primary flashing at opening. Attic vent flanges are on top of tile and should be under tile.

8. Penetration has no lead flashing.

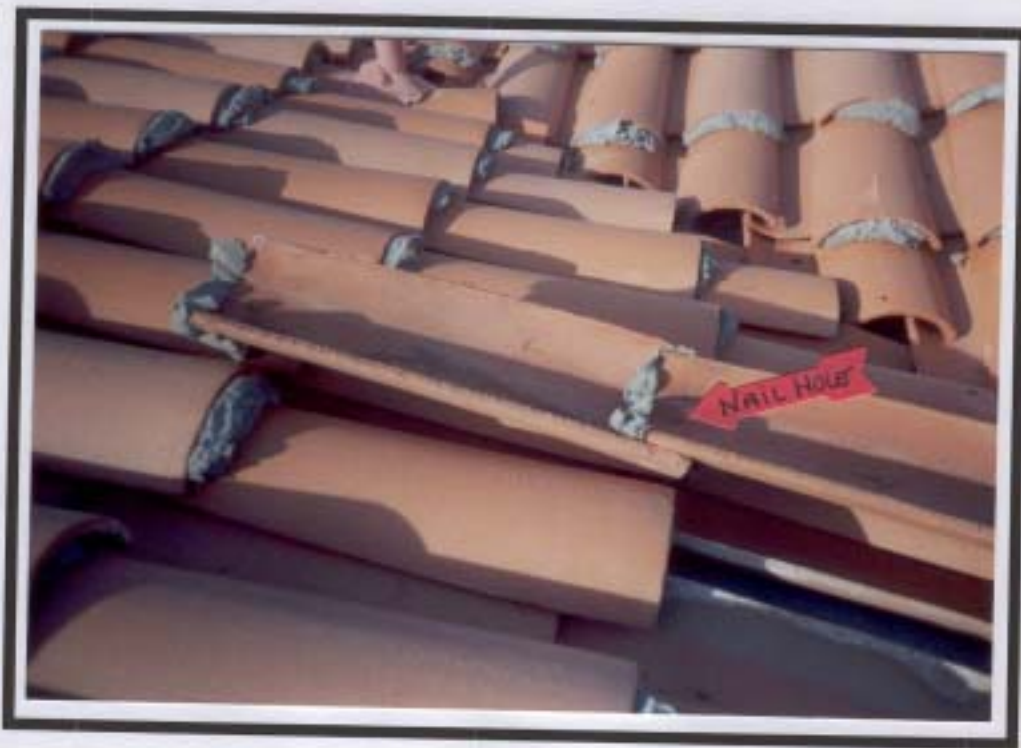
5. **Type of Substrate:** Plywood
6. **Conditions Noted*:**
 - a. Tile are overexposed. The minimum head lap of 3" is not achieved. Most commonly, the head lap is 2", with many only 1".

11. Tops have no fasteners and inadequate head lap.

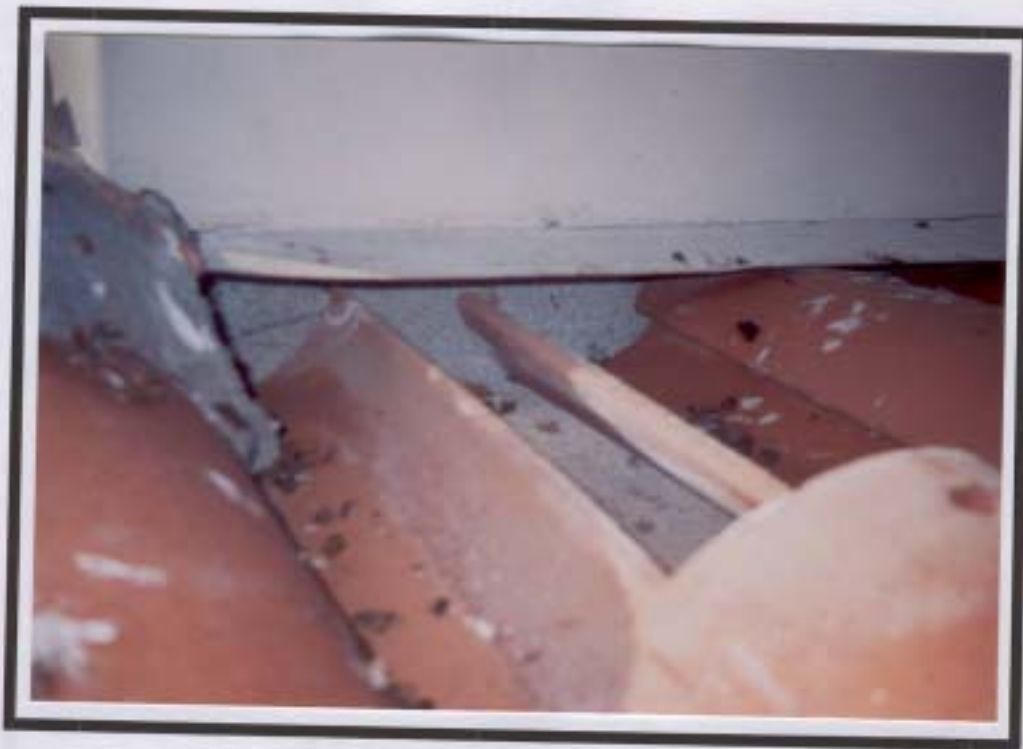
12. Inadequate size counterflashing.

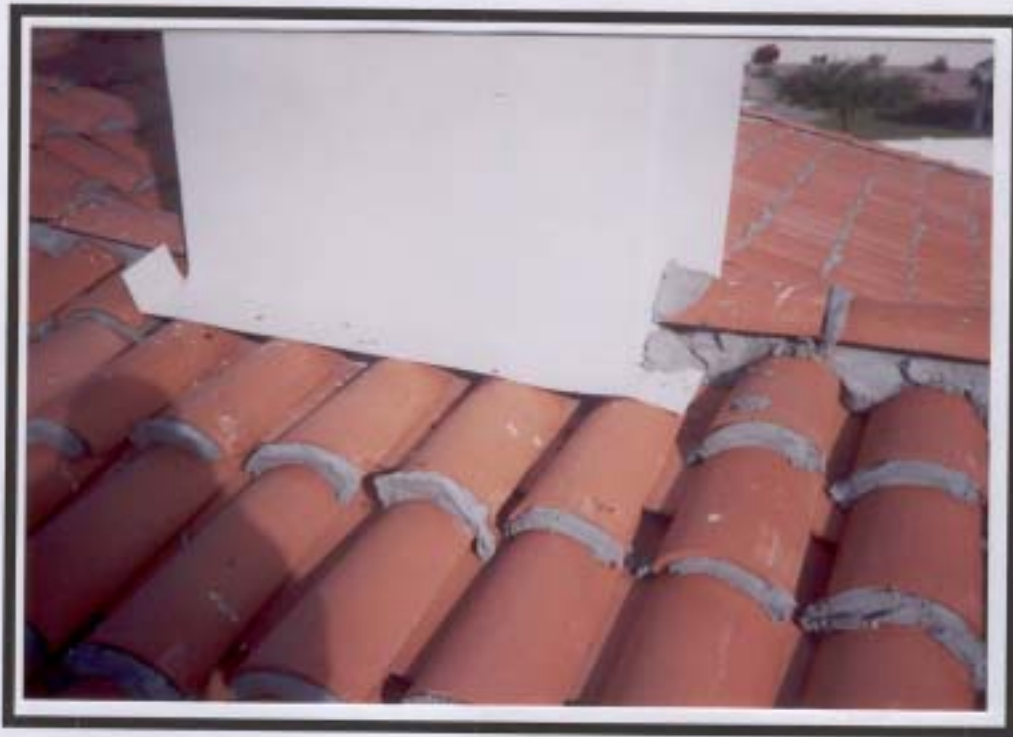
- f. Broken or missing tile are present, allowing moisture entry and exposing underlayment to ultraviolet damage.
 - g. Lack of mortar closures (mudballs) at chimney area will allow excessive moisture migration.

13. Exposed underlayment at chimney with neither metal or mud.

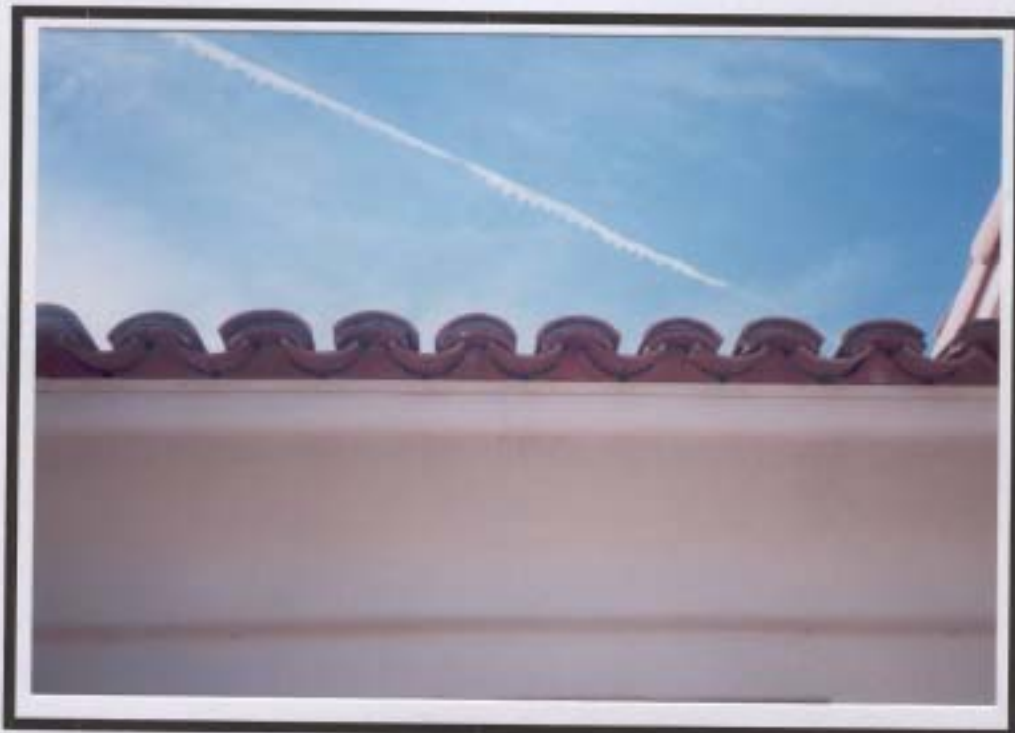
14. View at overhand drip edge.
